Assessment of the arm locking systems of two-post vehicle lifts

Prepared by the **Health and Safety Laboratory**
for the Health and Safety Executive 2015

Paul Woody and Alan McDonald
Health and Safety Laboratory
Harpur Hill
Buxton
Derbyshire SK17 9JN

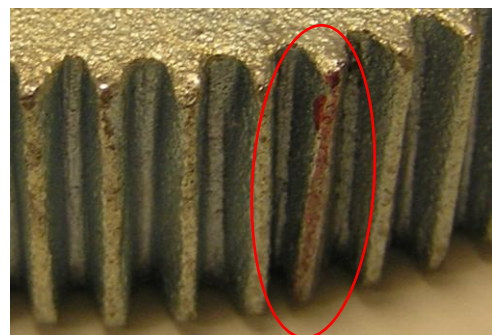
Figure 9: Post test-1 condition of the carrying arm gear (VL-1)

Figures 9 and 10 show the post-test condition of the gears. As can be seen, VL-1 failed to meet the requirements of the standard. On the 4.5% test there was permanent deformation visible on both the carrying arm gear (area circled in Figure 9 highlights where one of the gear teeth has plastically deformed) and locking block with the area circled in Figure 10 highlighting the indentations witnessed on the top land and tooth flank of some of the locking block gear teeth.

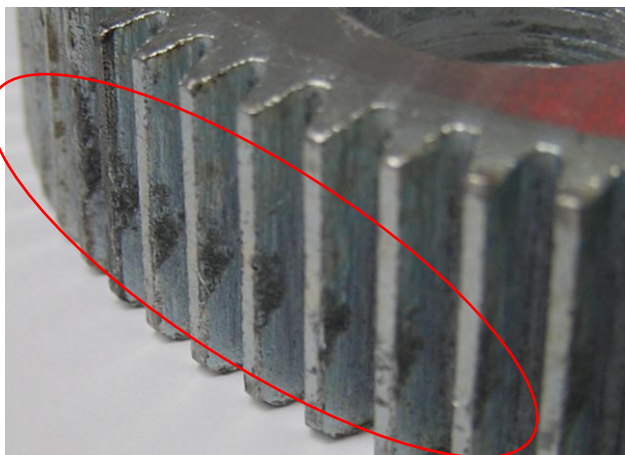
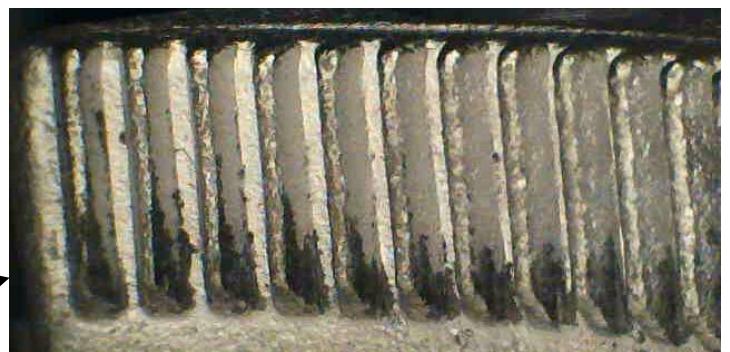
Figure 23: Post test-2 condition of the gears (VL-4)

On the 6.75% test, there was an increase in the amount of permanent deformation visible on the carrying arm gear and locking block (see Figure 23). However, as the locking system did not fail at an applied load of 229Kgf, it was deemed to have satisfied the requirements of BS EN 1493:2010¹.

VL-4 had what looked like a well manufactured arm gear (with a pronounced tapered profile). However, this was used in conjunction with a locking block which lacked the same profile, and therefore did not fully engage. As there was limited adjustment available, this meant that the locking system had a slight stand-off. However, it was observed that VL-4 had minimal end float of the carry arms when positioned and locked. Although VL-4 failed the 4.5% load test, it passed the 6.75% test, and therefore met the requirements of BS EN 1493:2010¹.

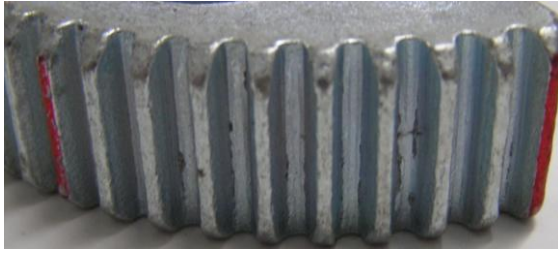
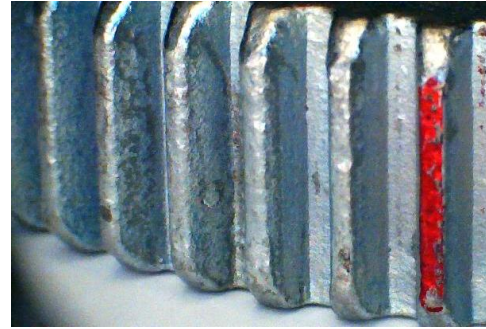
Figure 26: Post test-1 (8.8 grade bolts) condition of the carrying arm gear (VL-5)

As the bolts are an integral part of the locking system, the repeated shearing of the bolts securing the carrying arm gear can be classed as a failure to meet the requirements of BS EN 1493:2010¹. However, so the functionality of the locking system gears could be tested, the bolts supplied with the vehicle lift were exchanged for more appropriately rated 8.8 grade bolts that had been supplied by HSL – Engineering Support. With these bolts in place, the locking system failed to pass the 4.5% load test as there was permanent deformation in the form of burnishing along the bottom land of the locking block and arm gear (see Figures 25 and 26).

VL-5 had little to no adjustment available in the locking gears to remove any of the backlash experienced. After conducting the testing, the failure of the locking system was not due to the construction of the gears used (as has been demonstrated in the results - Section 6.1.5), but the bolts that had been supplied with the vehicle lift to secure the arm gear to the carrying arm.

However, one improvement that has been tested, and can be recommended with a degree of certainty, is to improve the grade of bolts used to secure the arm gear to the carrying arm on VL-5. This improvement was tested (see section 6.1.5), and enabled VL-5 to pass the requirements of BS EN 1493:2010¹.

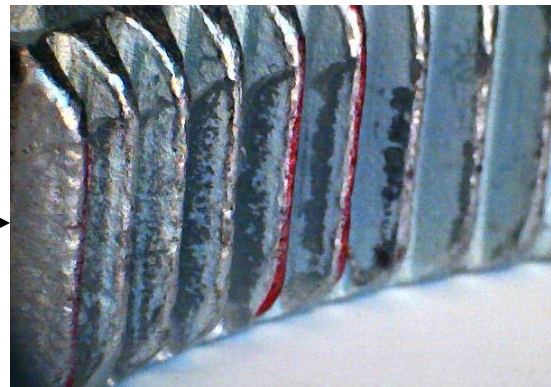
Figure 27: Post test-2 (8.8 grade bolts) condition of the locking block (VL-5)

Like VL-4, the locking system was able to pass the 6.75% load requirements (using 8.8 grade bolts supplied by HSL – Engineering Support), although there was an increase in the amount of indentations and surface burnishing (seen as discolouration to the tooth flank) visible on both the locking block and carrying arm gear teeth (see Figures 27 and 28).

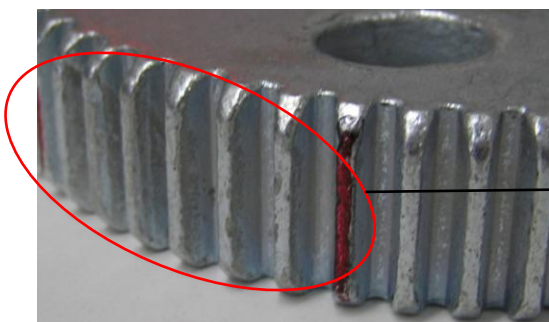
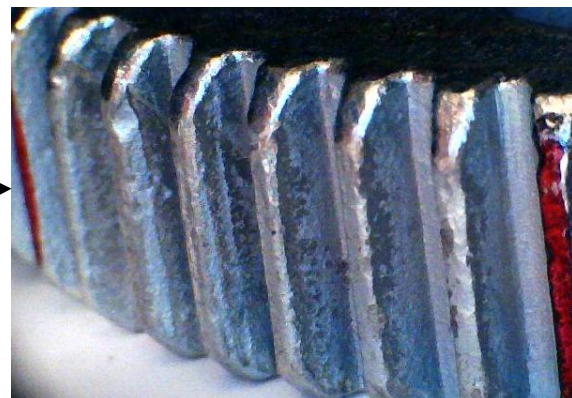
Figure 28: Post test-2 (8.8 grade bolts) condition of the carrying arm gear (VL-5)

The bolts used to attach the arm gear, were exchanged for improved bolts supplied by HSL – Engineering Support. Although VL-5 still failed to pass the 4.5% load requirement due to visible deformation on the tooth flank, it did manage to meet the 6.75% load requirement, and therefore pass the requirements of BS EN 1493:2010¹.

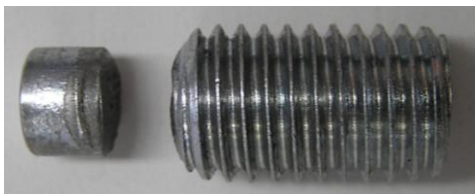
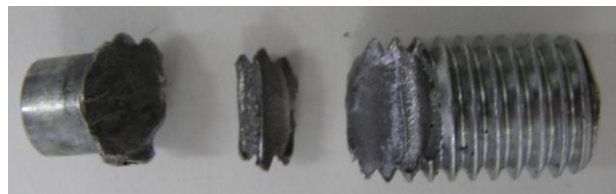
Figure 30: Sheared securing dowels (VL-6)

VL-6 managed to pass the 4.5% load test with no visible damage to any of the gear teeth, and therefore met the requirements of the standard. During test-2, the metal dowels securing the carrying arm to the pin, failed at an applied load of 180Kgf (6.75% load test). As the engagement of the locking gears was good, the moment being applied was transferred straight to the securing dowels, which sheared (see Figure 30).

for the operator to be able to see whether the carrying arm is correctly secured prior to operating the lift. VL-6 met the requirements of the 4.5% test but failed to meet the requirements of the 6.75% SWL test due to sheared retaining dowels. VL-7 used the same dowels to secure the locking system into the carrying arm as those used by VL-6. However, VL-7 was able to pass both the 4.5% and 6.75% SWL tests as the locking system uses three securing dowels as oppose to the two seen on VL-6.

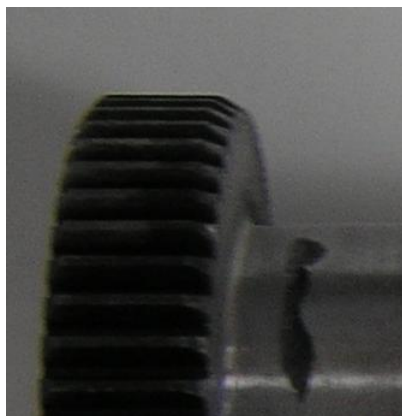
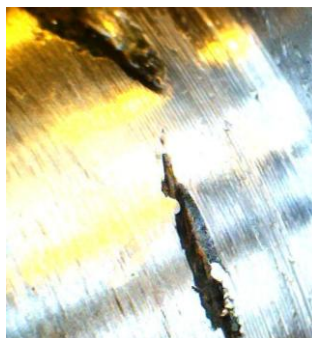
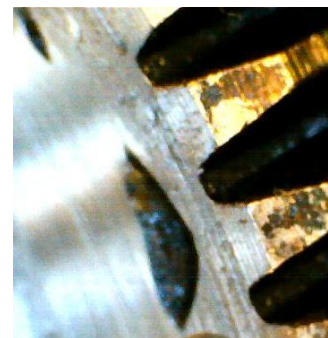
Figure 32: Notches in the pin and spur gear (VL-7)

Upon examination of the gears prior to conducting the test, and although most likely inconsequential to the quality of the locking system as a whole, it was noted that there were notches in the securing pin, as well as in the spur gear (see Figure 32). These were most likely due to voids that had formed below the surface during the casting process, and had been exposed during subsequent machining.
