Assessment of the arm locking systems of two-post vehicle lifts

Prepared by the **Health and Safety Laboratory**
for the Health and Safety Executive 2015

Paul Woody and Alan McDonald
Health and Safety Laboratory
Harpur Hill
Buxton
Derbyshire SK17 9JN

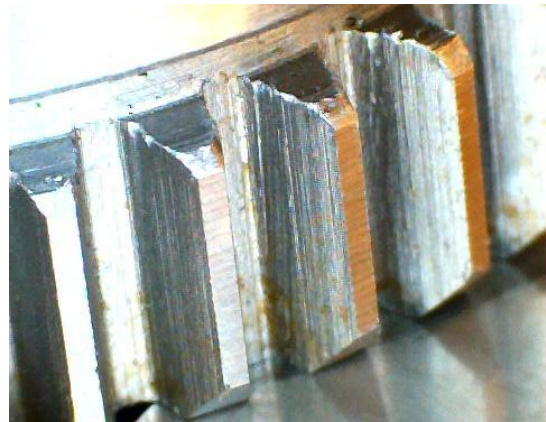
Figure 29: Quality of VL-6 locking system (manufacture and engagement)

On VL-6 the general quality and construction of the locking system appeared to be good. The locating holes in the locking system (for the dowels securing the carrying arm) can be seen in Figure 29.

Figure 29 shows the gear teeth and engagement achieved when using a 360° interlocking system, with no backlash in the carrying arm locking system once correctly positioned and locked.
